Report Title: Arboricultural Tree Survey Report

Project: Title: Proposed Large Scale Residential Development at
“Gowan Motors Compound” site, Merrion Road, Dublin 4.

Applicant: 1 Merrion Compound Land Limited

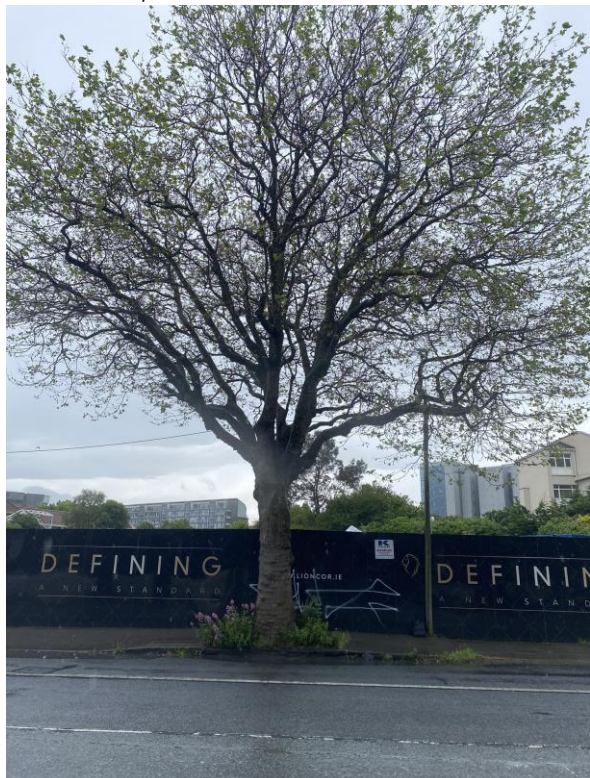
Photo 2: London Plane Street tree no. 1552 seen from road.

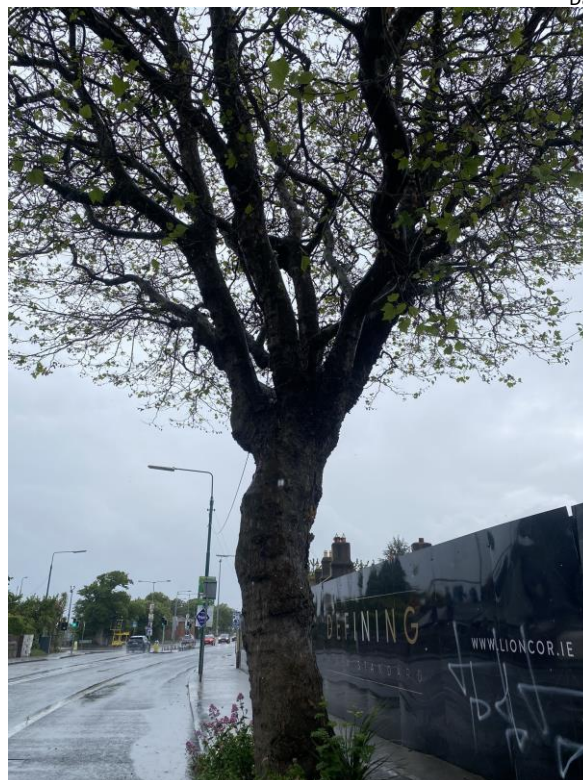
- 6.5 The tree has a stout bow-shaped main trunk that is generally clear to about eight metres. The tree is forked from about 5m resulting in about 8 no. co-dominant stems. The tree was pruned and crown-raised in the past resulting in clear stems to about eight metres. There are minor pocket cavities along the minor limbs on the southeastern side. There is possible water retention and/or ingress of water at the forking point. An aerial inspection is

Photo 3: Views of tree from north-western side with bow-shaped stem.

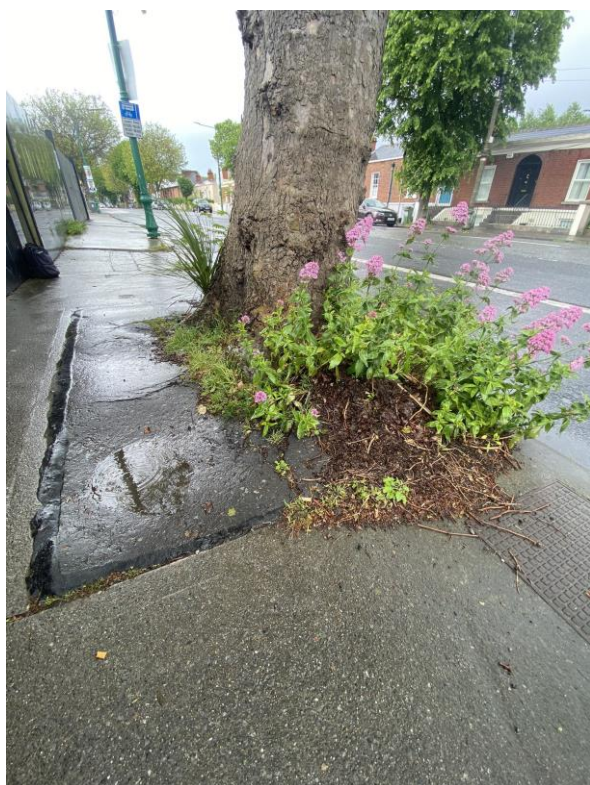
- 6.4 The tree has a paved over root flare with tarmacadam surfacing. The tree is growing in limited and restricted rooting conditions caused by poor planting pit design. There are signs of root plate lift to the tarmacadam surface around the base of the tree. There is cracking and upheaval of the tarmacadam surfacing and disruption and distortion of the road verge probably caused by tree roots. This could lead to impaired root function, good root development or affect tree stability. Good tree vitality could also be affected.

Photo 4: Views of pavement lift on footpath.

- 7. Preliminary Tree Works:**
- 7.1 Preliminary remedial works include pruning and crown raising or reshaping and cleaning to remove all dead, storm damaged and weak limbs and general pruning and cleaning works to improve shape and form. An aerial inspection of the main forking point and crown is also recommended. A re-design of the planting pit and surrounding pavement is also to be considered.

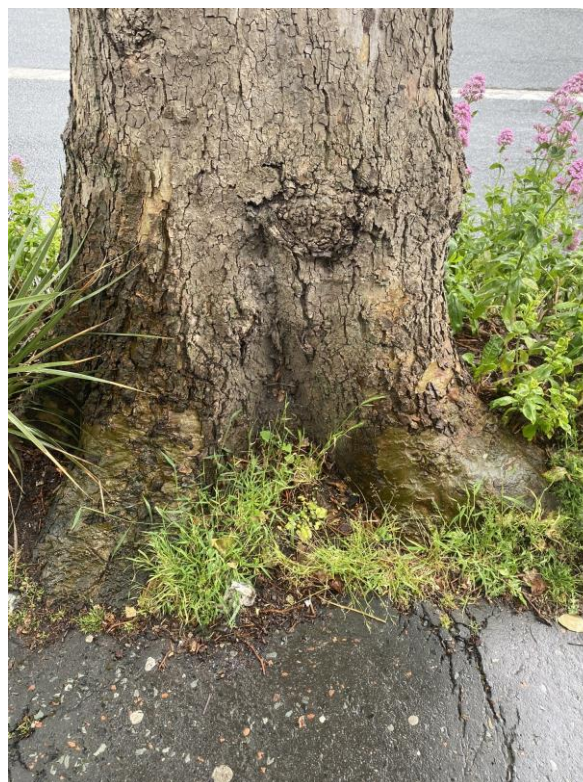
Photo 5: Paved over root flare to within about 400mm of main trunk.

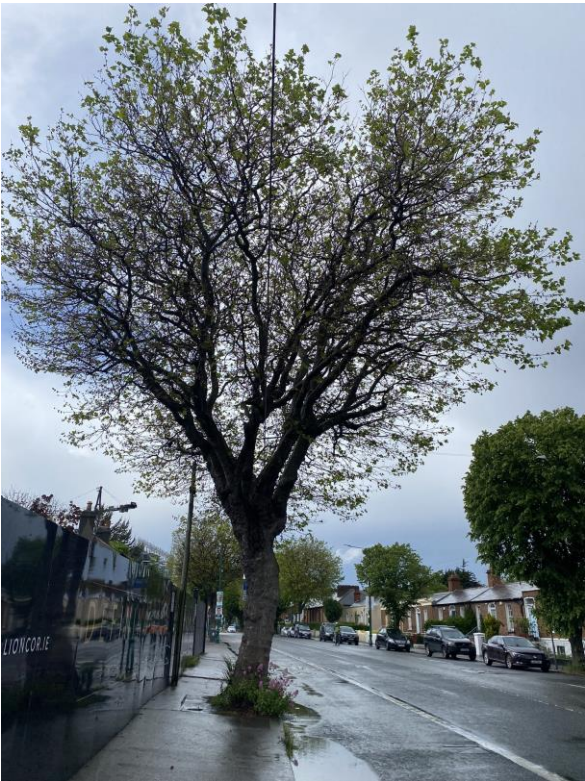
Photo 6: Views of tree from south-eastern side.

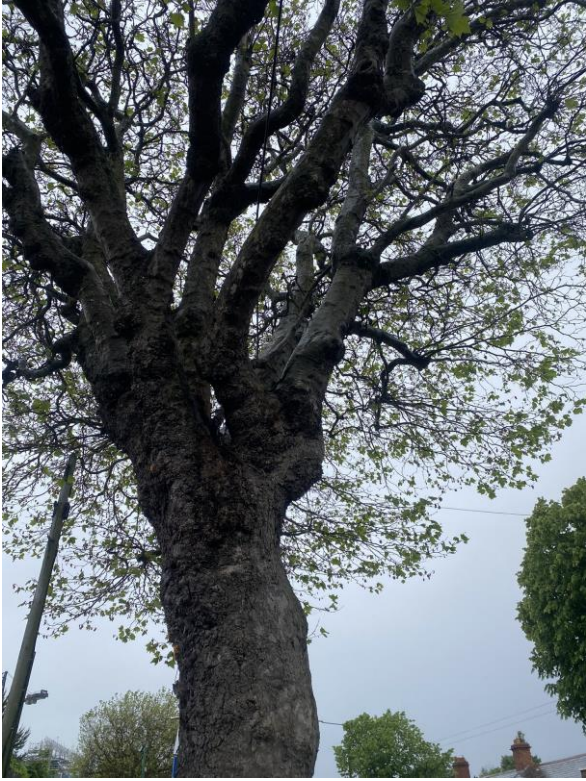
recommended. The trunkwood appears sound following an on-site mallet test during out site inspection. There is a cable running through the forking point at about 5m. There are patches of orange-coloured fungal spores on the bark surface at about three meters on the western side.

Photo 7: Views of main forking point - main trunk.

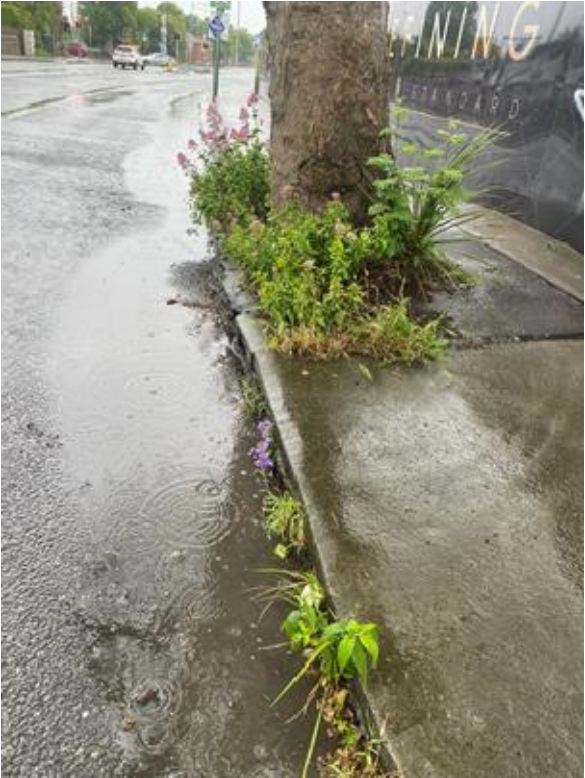
Photo 8: Views of distortion to kerb adjacent to road.

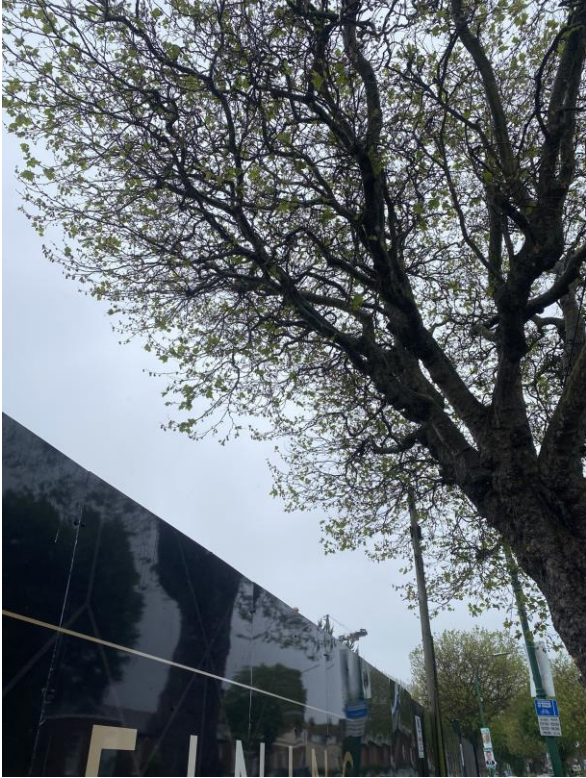
- 6.6 The tree has a reasonably well-balanced crown with over-extended limbs to the northwest and southeast. Limbs extend over the Merrion Road where there are heavy traffic flows. There is a broken central stem and deadwood throughout the crown. There is minor deadwood throughout the crown. There are signs of some foliage wilt throughout the crown possibly Anthracnose leaf blight or other underlying disorder. The crown has about 70% leaf cover at the time of inspection.

Photo 9: Limbs overhang site hoarding to west.
